# **CANTILEVER TESTING OF CONCRETE-FILLED STEEL DECK COMPOSITE DIAPHRAGMS USING VARIOUS TYPES OF STEEL REINFORCING**

May 2021

COLD-FORMED STEEL RESEARCH CONSORTIUM  
REPORT SERIES  
**CFSRC R-2021-02**

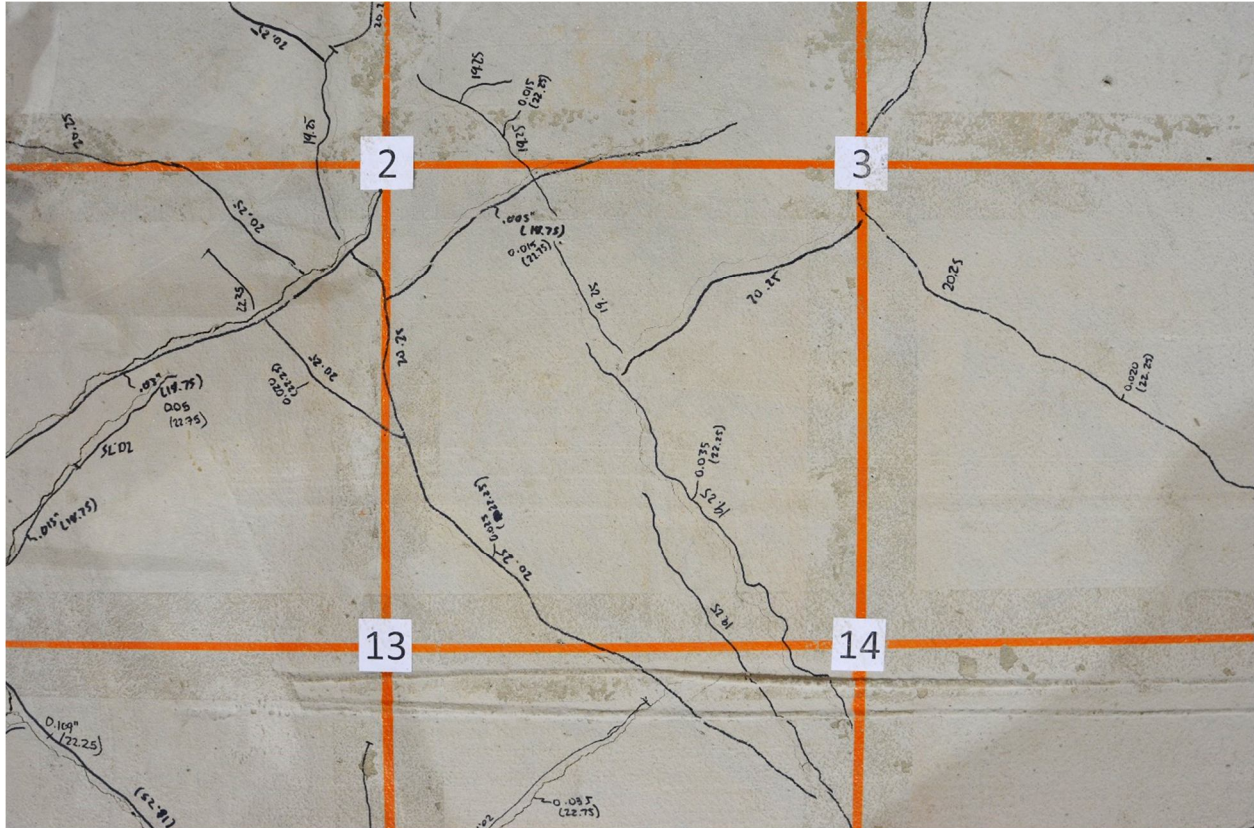
Figure 2-16. Sample Image used in Photo-Stitching

and ending on the bottom right corner. One of the grids is shown in Figure 2-15. Another purpose of the grid was to facilitate photo stitching used to produce high-resolution pictures of the entire slab at several points during the test. This is done by taking pictures of each individual square in the grid and using software to overlap the individual images into a large high resolution composite image of the entire specimen. The grid provides easily identifiable overlap between the images which aids with the process. An example of an image used as part of a larger composite image is shown in Figure 2-16.

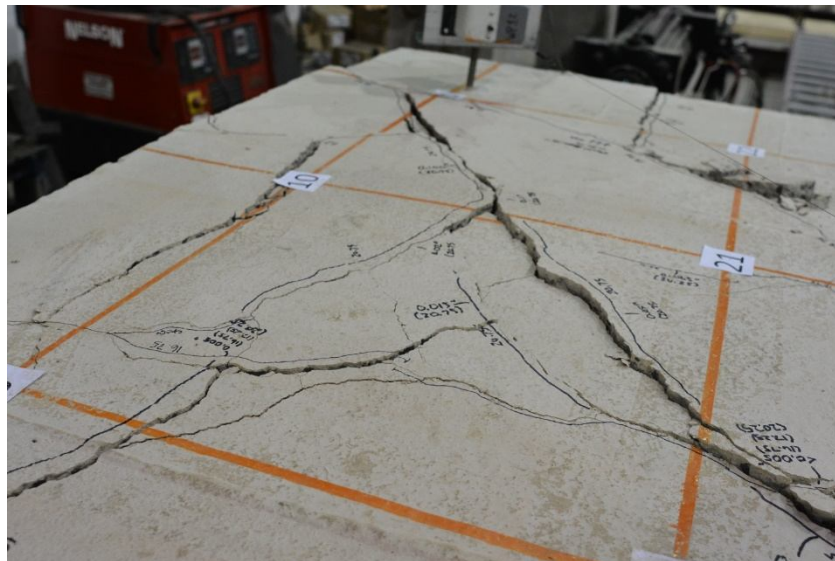
Figure 3-9. Slab Buckling (Point D in Figure 3-4)

While not visually evident, crackling noises consistent with deck debonding were heard before peak load was reached. A subsequent increase in strength was observed with additional cracking until Point C in Figure 3-4, the diagonal tension cracking was observed to extend the full width of the specimen (Figure 3-7). The shear strength of the specimen then decreased with each displacement step with subsequent crack formation as well as deformation of the steel deck and buckling of the slab. Steel deck deformation and debonding (Figure 3-8) near the edges of the specimen was observed near Point D in Figure 3-4 as well as buckling of the slab (Figure 3-9).

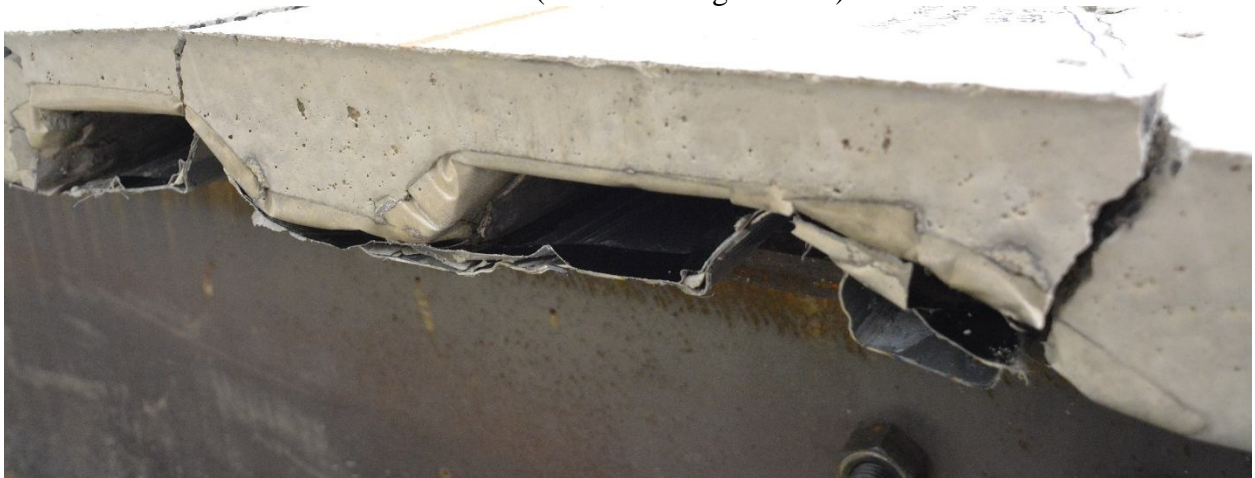
Figure 3-27. Deck Debonding and Overhang Cracking (Point E in Figure 3-22)

Distortions of the deck as well as cracking near the shear connectors was observed past this stage of the test, as shown in Figure 3-27. As shown in Figure 3-28, the damage of the specimen in the last cycles of the test concentrated along the left edge of the slab. The deck along this damage plane was seen to distort as loading continued, contributing largely to the deformation of the specimen during this stage.

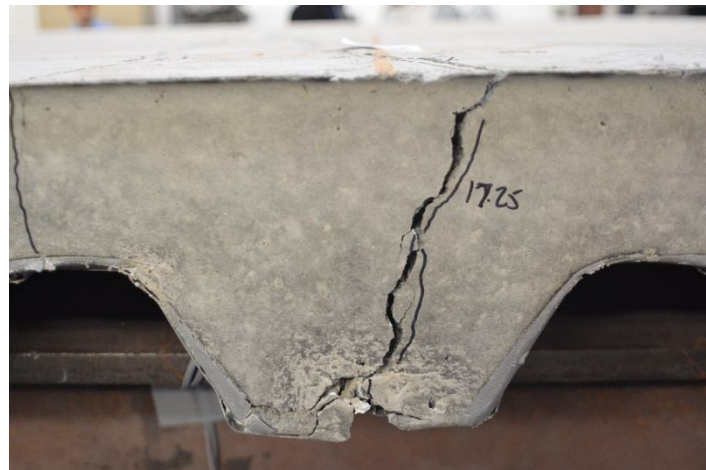
Figure 3-34. Shear Transfer Damage at Peak Load

At peak load (Figure 3-31 Point B), cracks formed on the slab between the location of two studs. Strain gauge data showed a drop in the difference in axial strains of the beam on either side of L3 at peak load, which indicates failure of the shear connection. This is supported by strain gauge observations for later cycles which show constant axial strains in the beam segment between L2 and L4 at subsequent peaks. As shown in Figure 3-34, at peak load, evidence of shear transfer failure can be observed on the edges of the specimen.

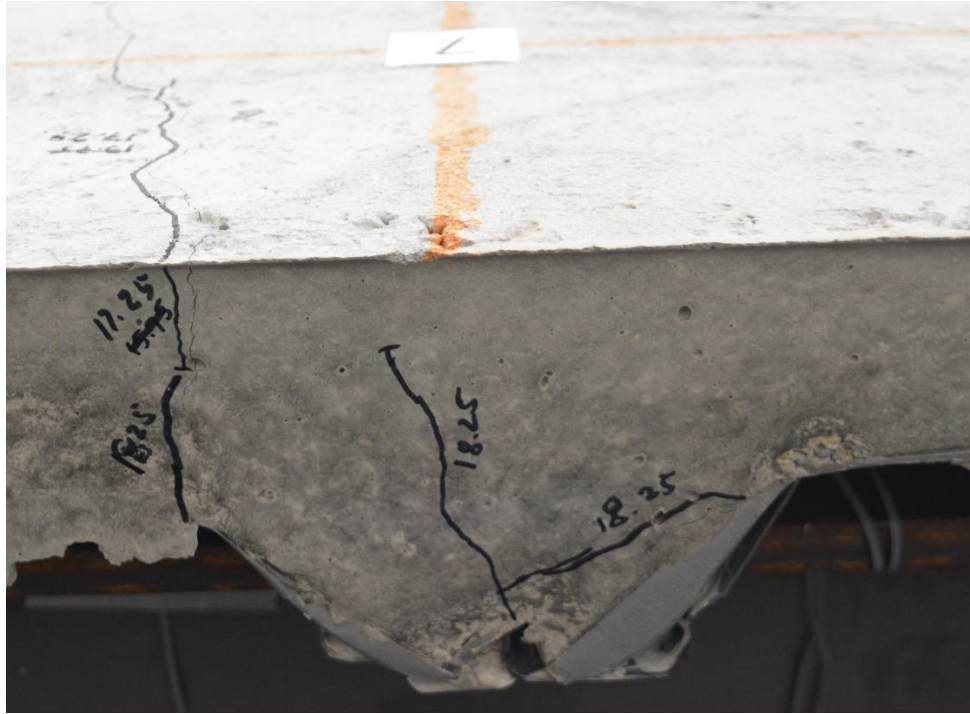
Figure 3-35. Shear Transfer Damage at Peak Load

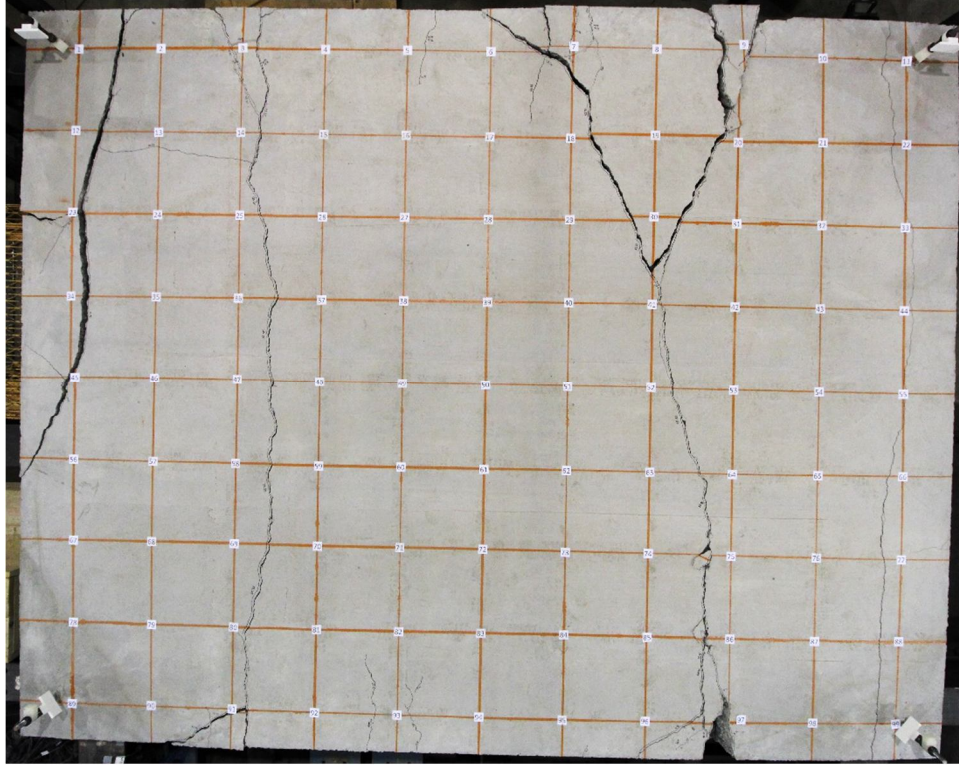
Figure 3-38. Crack Distribution of Specimen 3/6.25-4-L-NF-P End of Test (Point E in Figure 3-22)

Further cracking of the specimen was observed at Point C in Figure 3-31, as shown in Figure 3-36. Evidence of rib shear was found on all the ribs of both the loading beam and the fixed beam by the time the test ended, as shown in Figure 3-37. The state of the specimen after the test was concluded is shown in Figure 3-38. The shear transfer failure was confirmed after the test as evidence by failure surfaces such as the one shown in Figure 3-39.

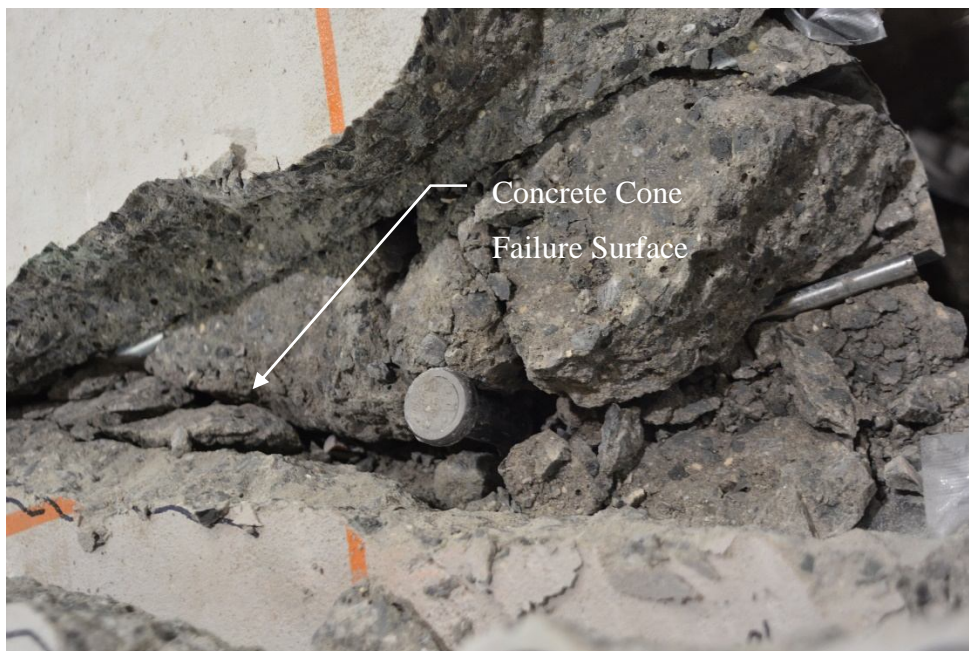
Figure 3-39. Evidence of Concrete Pullout Failure After Test

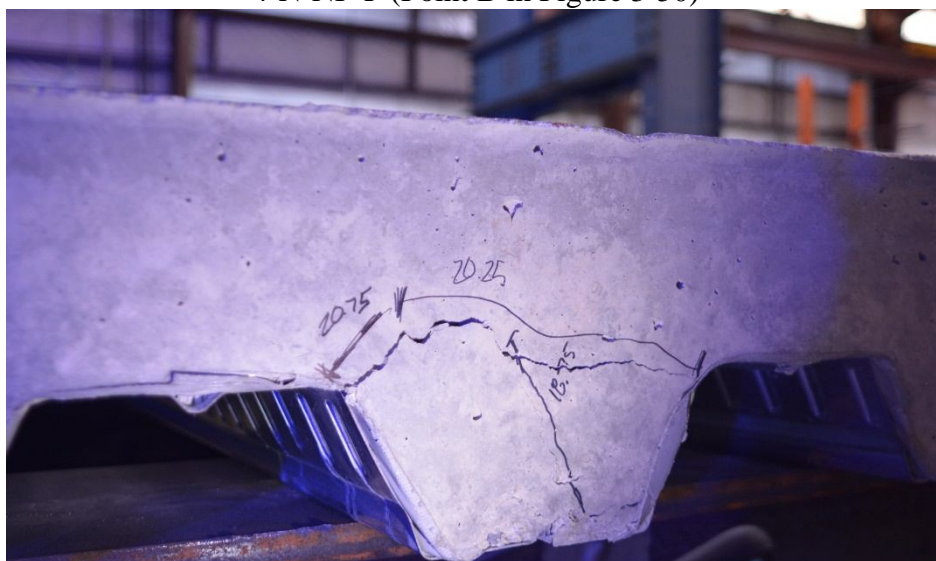
Figure 3-53. Rib Shear Cracks Along Shear Connection (Stud L1) in Specimen 3/7.5-4-N-NF-P (Point C in Figure 3-50)

At peak load (Figure 3-50 Point B), evidence of shear transfer failure was observed on the rib in which stud L1 was located, as shown in Figure 3-52. At Point C of Figure 3-50, additional damage appeared on the same rib consistent with rib shear failure, as shown in Figure 3-53. At Point D of Figure 3-50, damage consistent with a concrete pullout failure mode appeared on the ribs in which stud L3 and L4 were located, as shown in Figure 3-54. At Point E in Figure 3-50, all four ribs of the loading beam containing studs exhibited some amount of damage consisting with a shear transfer failure, similar to that seen in Figure 3-55. Past this point in the test, the deck deformed and the damage of the ribs became more extensive, as shown in Figure 3-56.

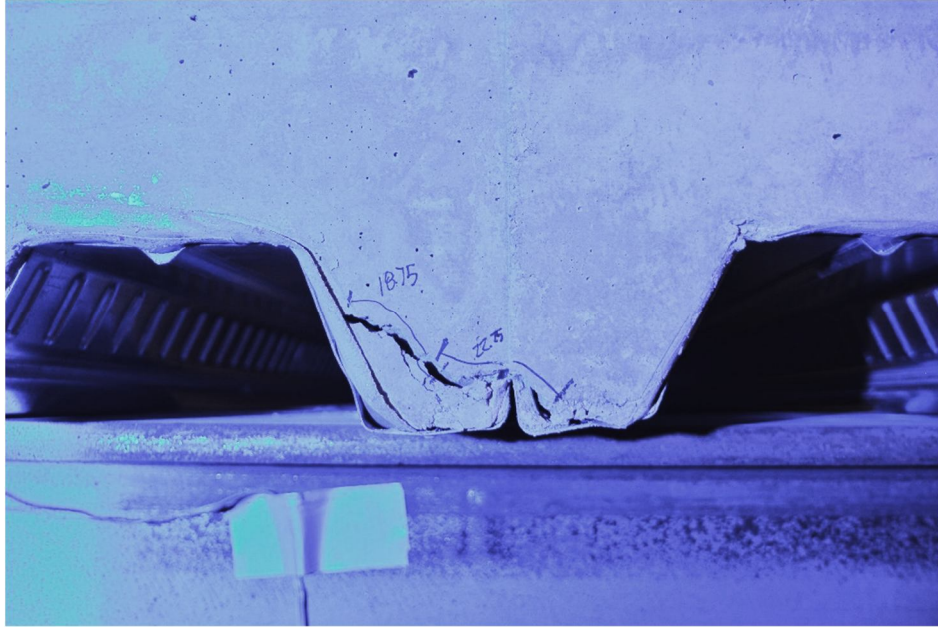
Figure 3-54. Concrete Pullout Cracks Along Shear Connection (Stud L3) of Specimen 3/7.5-4-N-NF-P (Point D in Figure 3-50)

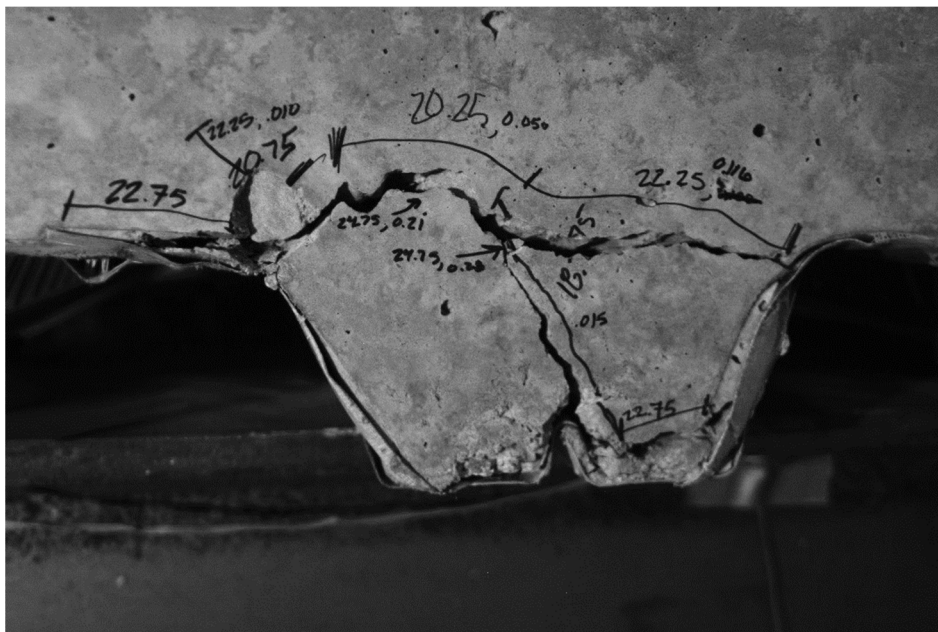
Figure 3-55. Rib Shear Cracks Along Shear Connection (Stud L1) Specimen 3/7.5-4-N-NF-P (Point E in Figure 3-50)

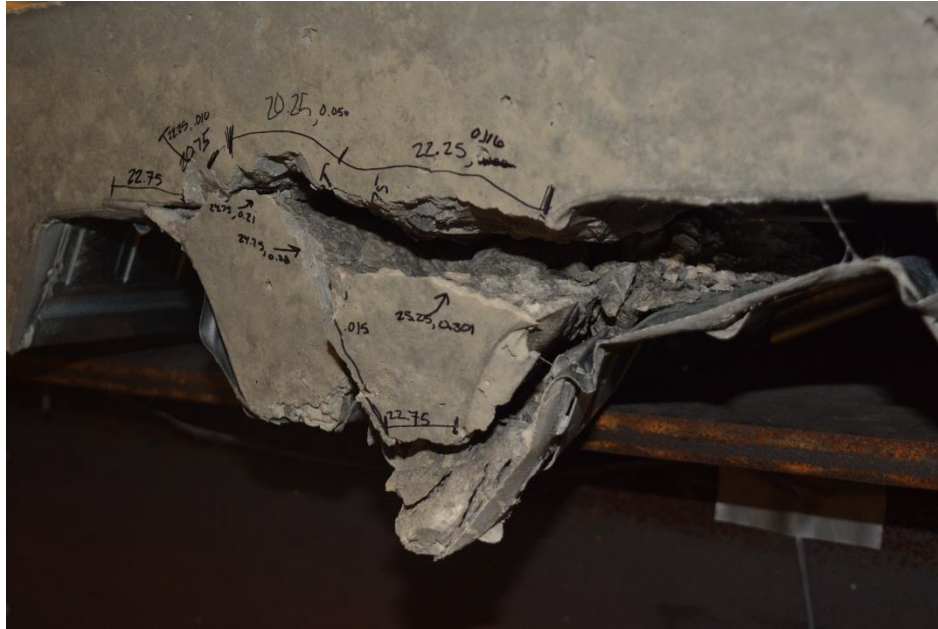
Figure 3-56. Damage at End of Test (Stud L1) Specimen 3/7.5-4-N-NF-P (Point F in Figure 3-50)

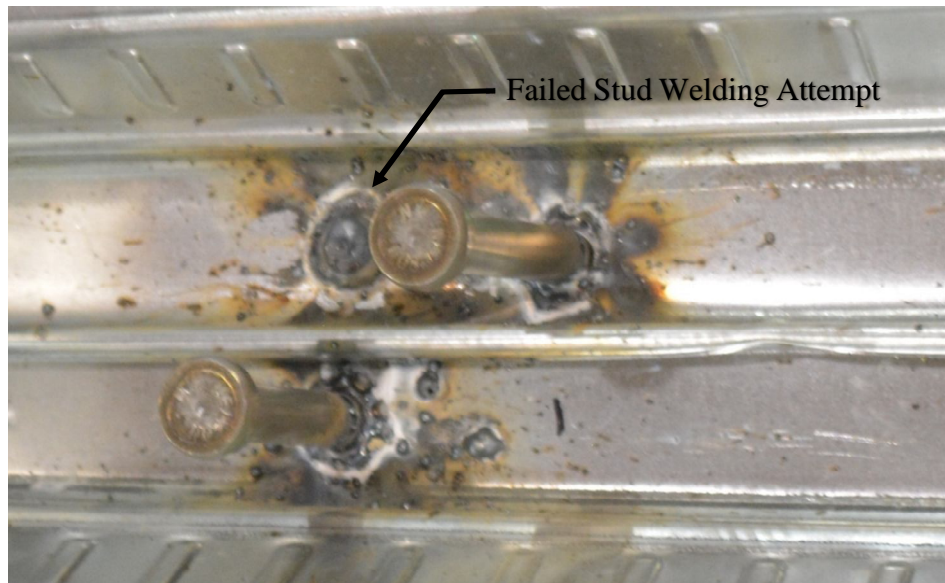
Figure D-1. Failed Stud Welding Attempt in Specimen 3/6.25-4-L-NF-DT

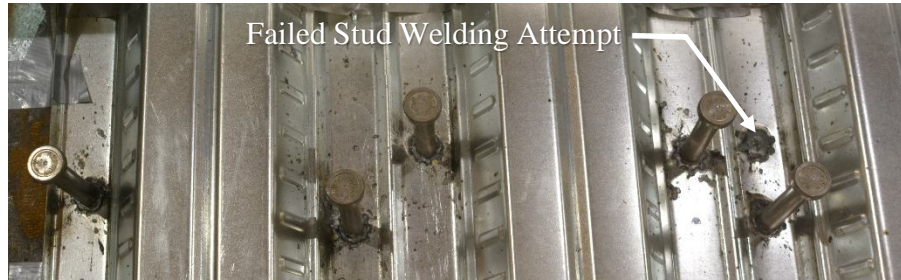
Figure D-3. Failed Stud Welding Attempt in Specimen 3/7.5-4-N-NF-DT

During the construction of this specimen, the stud welder malfunctioned during the welding of one of the headed studs in the fixed beam, as seen in Figure D-3. As a result, the studs in that rib were staggered differently from the rest of studs, as seen in Figure D-4.

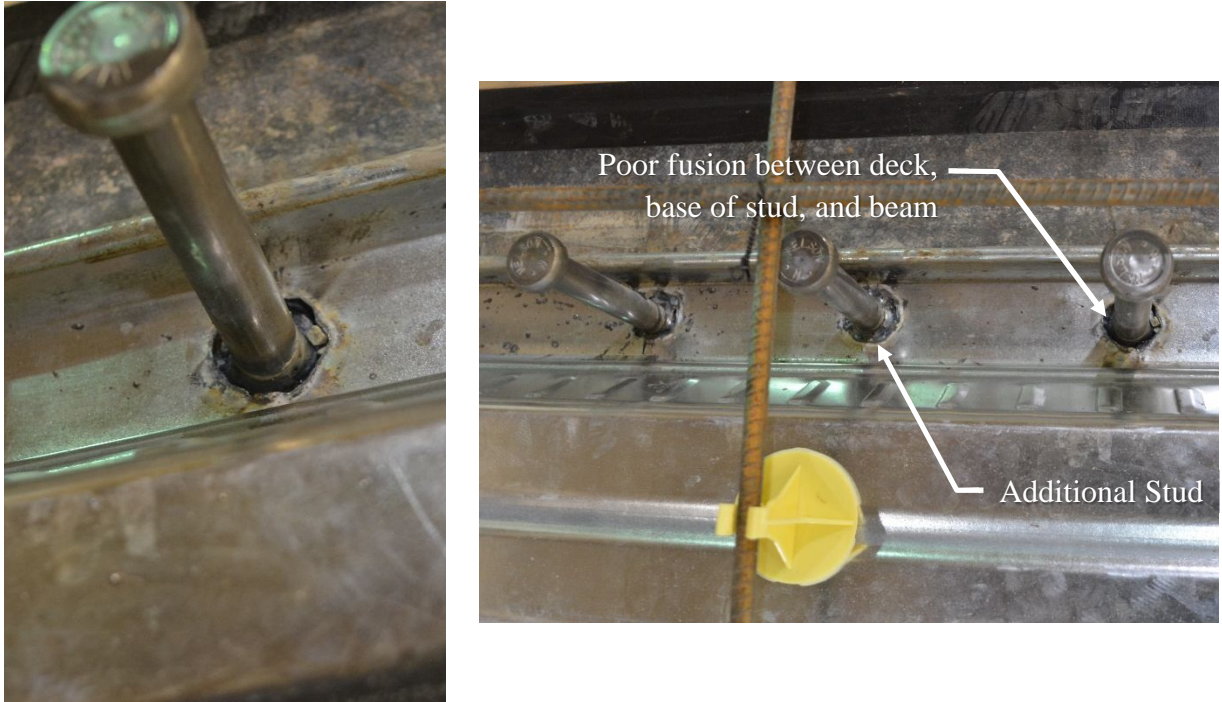
Figure D-5. Poor Fusion Between Weld at Base of Stud, Steel Deck, and Top Flange of Beam for Specimen 3/7.5-NW-NF-RS

During the construction of this specimen, poor contact between the steel deck and the top flange of the beam, prior to welding of one of the studs in one of the side beams, resulted in poor fusion of the weld at the base of the stud, the steel deck, and the top flange, as shown in Figure D-5. An additional stud was welded six inches away from the affected stud to compensate. The location of the issue is shown in Figure D-6.
